Manhole Inspection Summary

Manhole # S31II_040MH

Insp Date: **5/9/07 9:37 AM**

Location Address: **1233 MOUNT ROYAL AVE**

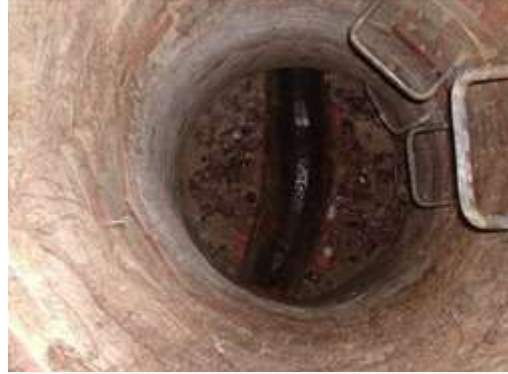
Top View

Corroded steps. Bench debris.

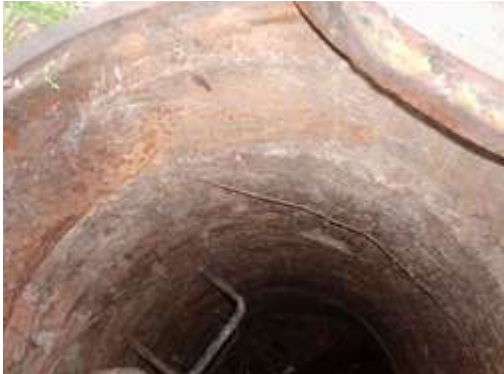
Defect

Adjustmment, Corbel and Barrel root intrusion and infiltration - other side.

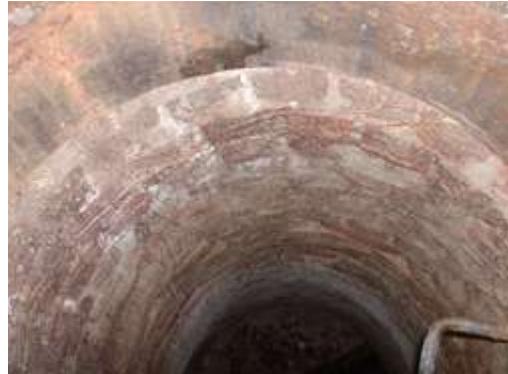
Defect

Adjustmment, Corbel and Barrel root intrusion and infiltration.

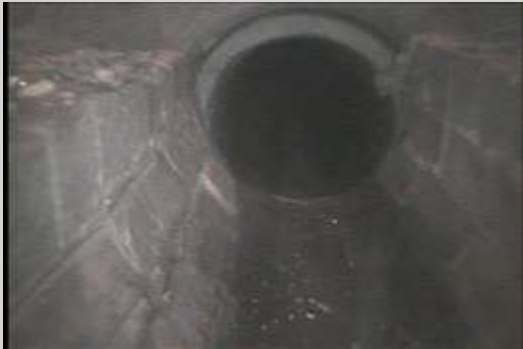
12 in. Circular Gravity Sewer Pipe Out @ 12 O'Clock

Infiltration: **Evidence** Pipe Seal Cond: **Unknown**
